**Flood Control Project Maintenance  
Levee Inspections**

**Fall 2018 Levee Maintenance Deficiency Summary Report**

**Reclamation District No. 0900 West Sacramento**

Waterway			Bank	Unit Miles
Unit No. 01 Sacramento River			Right	7.70
	Spring (March - May)	Summer (June - August)	(September - November) Fall	Winter (December - February)
Unit Maintenance Rating (Fall Only)			<b>A</b>	
Date of Inspection	3/13/2018 - 3/13/2018		10/18/2018 - 10/18/2018	
DWR Inspector	Dave Torres		Luz Dial	
Accompanied By	Chris Fogel RD 900		Tony Schwall RD 900

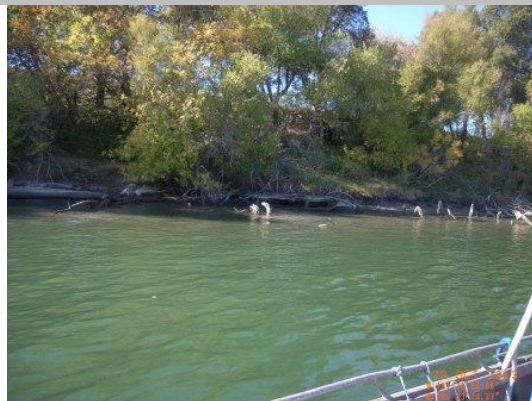
Photo 1 of 1 : FA\_2018\_RD0900\_230\_30\_20181023\_00024.jpg

LM Start	2.35	Rating **	M	Issue No.	30
LM End	2.47	Issue Type +	Ma	Location *	WS
Category	Supplemental			GPS Latitude/Longitude	
				Start	End
Item	2017 USACE Erosion Survey, DRAFT			38.554277 °	38.552504 °
				-121.515263 °	-121.514752 °
DWR ID	DWR_RD0900_01_f_2018_30				
Comment Code					
Inspector Comment					
2017 Site ID: SAC 56.7 R					
Status: Eroding					
2017 Field Notes: Fresh toe erosion. New rock placed.					
Site History: 2007 - Have good berm width with minor toe erosion.					
Close to the levee toe protection, but levee slope is steep. 2011 - New large erosion pocket. 2012 - Minor new erosion at the toe.

USACE 2013 Photo #1

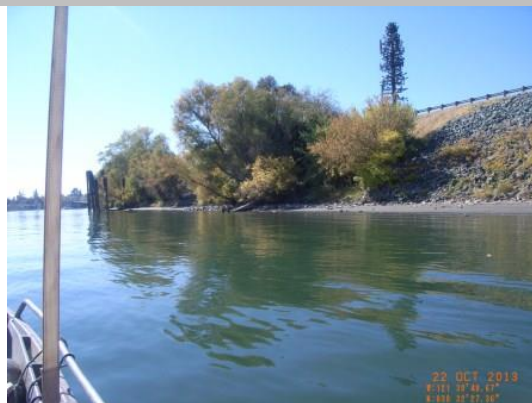
Photo 1 of 1 : FA\_2018\_RD0900\_230\_28\_20181023\_00022.jpg

Comment Code					
Inspector Comment					
2017 Site ID: SAC 55.7 R					
Status: Critical					
2017 Field Notes: Fresh toe erosion. Site upgraded to critical. A setback levee is under construction behind this site.					
Site History: 2008 - Erosion into levee toe. Over steepened levee slope, worst at the upstream end. 2009 - Near vertical banks from rotational slumping, hidden by vegetation. 2010 - Boat sinking more, may be causing eddy scour around it. Difficult to see the vertical slumps due to dense vegetation. 2011 - Minor new erosion at the toe. The paddleboat that was sitting at this site for years has been removed. 2012 - Site extended upstream due to additional erosion. 2016 - New rock on slope at upstream end.

USACE 2013 Photo #1

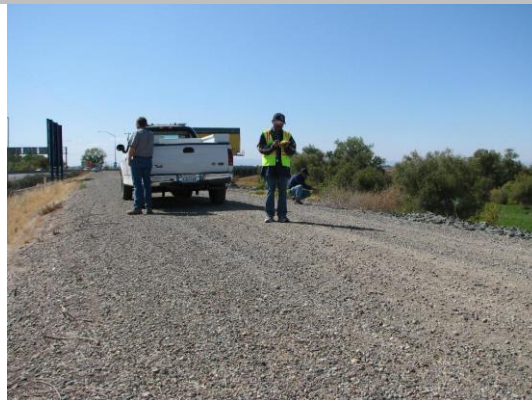
Photo 1 of 3 : UCIP\_FA\_2018\_41825\_72725.jpg

Comment Code						
Inspector Comment						
FS_ID:41825						
DS_ID:17862						
EP_NO: 2444						
Repair Type: Non-Urgent						
Crossing Status: Indicator Found						
UCIP Comments: Records show 3 gas lines in general area--unable to confirm alignment and status of crossing. Markers visible in general area are for Kinder Morgan and not the owner listed on permit. Need to contact owner to clarify if crossing is still present and if so determine status of crossing. Need date of last inspection and confirmation that crossing is still in operable condition.						
FIELD_STRUCT_DESC: 16-inch high pressure steel gas line through the levee, 3.0 feet below the levee crown. (16-inch pipe authorized under Permit No. 2444, 1956 - Pacific Gas and Electric Company [PG&E]) [Additional Reference(s): DWR Levee Log, 2003]						
FS Date: 10/5/2009

View of levee crown near marker.

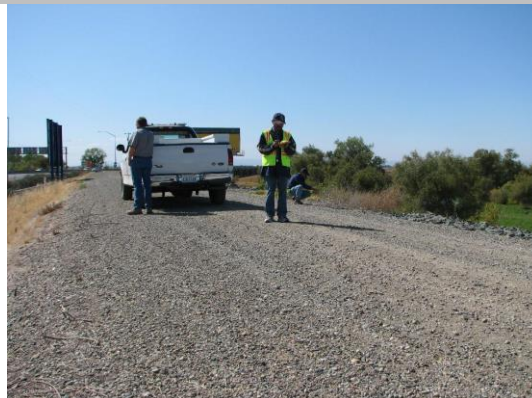
Photo 1 of 3 : UCIP\_FA\_2018\_41826\_72722.jpg

Comment Code						
Inspector Comment						
FS_ID:41826 DS_ID:17874 EP_NO: 17739 Repair Type: Non-Urgent Crossing Status: Indicator Found UCIP Comments: Records show 3 gas lines in general area--unable to confirm alignment and status of crossing. Markers visible in general area are for Kinder Morgan and not the owner listed on permit. Need to contact owner to clarify if crossing is still present and if so determine status of crossing. Need date of last inspection and confirmation that crossing is still in operable condition. FIELD_STRUCT_DESC: 20-inch petroleum pipeline across and under (bored) Willow Slough and its west levee, across (trenched) the Yolo bypass, and across and under (bored) toe drain and east levee. (20-inch pipe authorized under Permit No. 17739, 2004 - Paragon Partners Ltd.; name change authorized under Permit No. 17739-Rev, 2004 - SFPP, L.P., a Delaware Limited Partnership c/o Paragon Partners Ltd) FS Date: 10/5/2009

View of levee crown near marker.

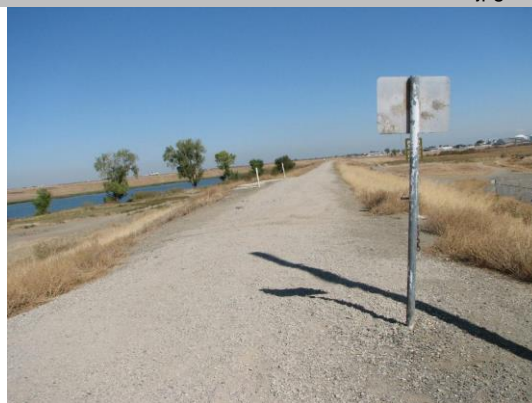
Photo 1 of 3 : UCIP\_FA\_2018\_37770\_68626.jpg

LM Start	3.23	Rating **	M	Issue No.	60
LM End	3.23	Issue Type +	En	Location *	
Category	Supplemental			GPS Latitude/Longitude	
				Start	End
Item	DWR UCIP Field Study			38.541353 °	38.541353 °
				-121.582202 °	-121.582202 °
DWR ID	17885				
Comment Code					
Inspector Comment					
FS_ID:37770 DS_ID:17885 EP_NO: 17070 Repair Type: Non-Urgent Crossing Status: Found UCIP Comments: Dense vegetation limits the inspector's visibility to identify signs of pipe failure (leaks) along the slope. Recommend removing vegetation along pipe alignment to conduct proper inspection of structure. FIELD_STRUCT_DESC: [Southport Business Park Storm Water Pump Station] 1 of 5. 30-inch steel drainage pipe through the levee, 2 feet below the levee crown. (12-inch pipe and four 30-inch pipes authorized under Permit No. 17070, 2000 - Reclamation District No. 900) FS Date: 10/5/2009

View of levee crown at crossing.

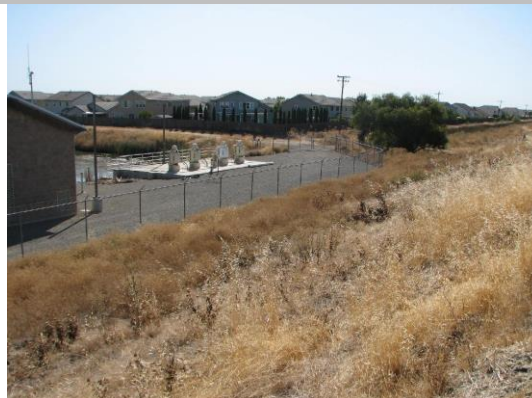
Photo 2 of 3 : UCIP\_FA\_2018\_37770\_68625.jpg

Pump station located on waterward side.

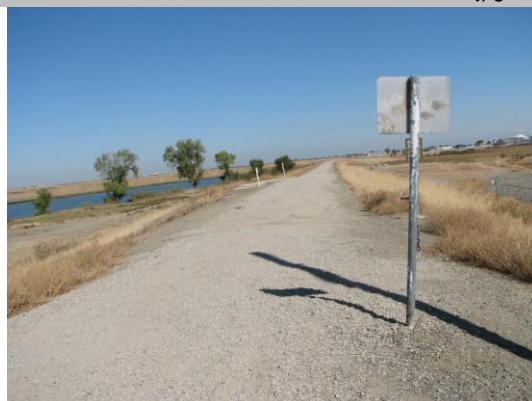
Photo 1 of 3 : UCIP\_FA\_2018\_37766\_68620.jpg

View of levee crown at crossing.

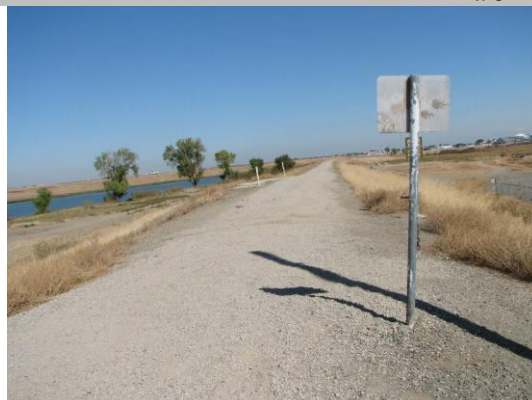
LM Start	3.23	Rating **	M	Issue No.	62
LM End	3.23	Issue Type +	En	Location *	
Category	Supplemental			GPS Latitude/Longitude	
				Start	End
Item	DWR UCIP Field Study			38.541311 °	38.541311 °
				-121.582201 °	-121.582201 °
DWR ID	17888				
Comment Code					
Inspector Comment					
FS_ID:37778 DS_ID:17888 EP_NO: 17070 Repair Type: Non-Urgent Crossing Status: Found UCIP Comments: Dense vegetation limits the inspector's visibility to identify signs of pipe failure (leaks) along the slope. Recommend removing vegetation along pipe alignment to conduct proper inspection of structure. FIELD_STRUCT_DESC: [Southport Business Park Storm Water Pump Station] 3 of 5. 12-inch steel drainage pipe through the levee, 2 feet below the levee crown. (12-inch pipe and four 30-inch pipes authorized under Permit No. 17070, 2000 - Reclamation District No. 900) FS Date: 10/5/2009

View of levee crown at crossing.

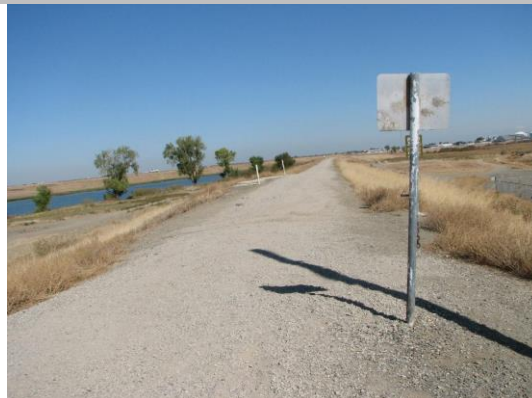
Photo 1 of 3 : UCIP\_FA\_2018\_37780\_68662.jpg

View of levee crown at crossing.

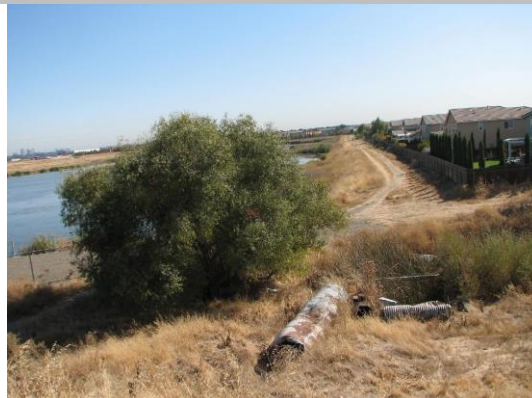
Photo 1 of 3 : UCIP\_FA\_2018\_37785\_68693.jpg

View of pipe sections visible on landward side.

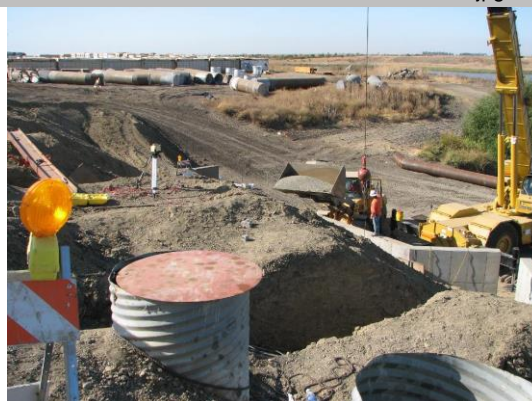
Photo 1 of 3 : UCIP\_FA\_2018\_37890\_68941.jpg

Construction of structures in Oct-2009, photo 1 of 3.

Comment Code						
Inspector Comment						
FS_ID:37890 DS_ID:17880 EP_NO: 18116 Repair Type: Non-Urgent Crossing Status: Found UCIP Comments: Under construction Oct-2009. Need updated photos of completed structure. FIELD_STRUCT_DESC: [West Sacramento Main Darin Pump Station] 1 of 4. 54-inch steel drainage pipe through the levee, 12.9 feet below the crown. Pump house is located on the landside (LS) and siphon breaker is located on the waterside (WS) slope. (four 54-inch pipes authorized under Permit No. 18116, 2007 - Reclamation District No. 900 [RD0900]; existing dual 48-inch pipes (60-inch pipes referenced in permit) removed; dual 48-inch pipes authorized under Permit No. 4257, 4257-A, 1963 - RD0900) [Additional Reference(s): DWR Levee Log, 2003] FS Date: 10/5/2009

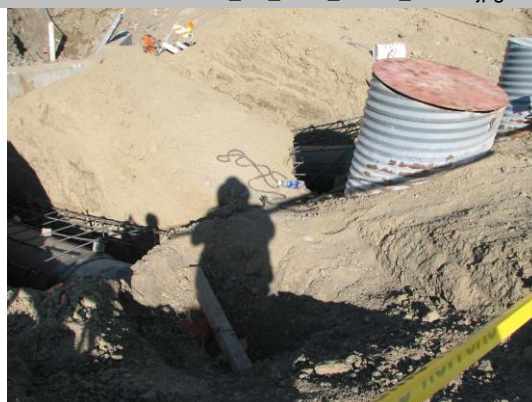
Photo 2 of 3 : UCIP\_FA\_2018\_37890\_68940.jpg

Construction of structures in Oct-2009, photo 2 of 3.

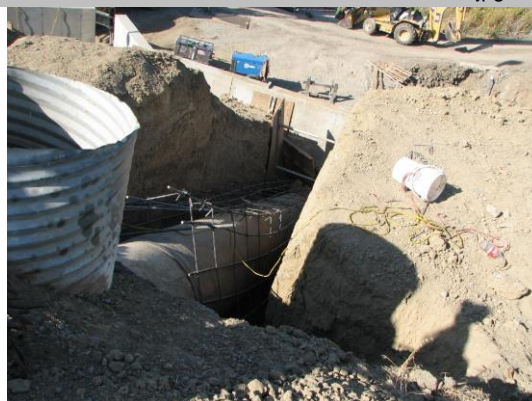
Photo 3 of 3 : UCIP\_FA\_2018\_37890\_68939.jpg

Construction of structures in Oct-2009, photo 3 of 3.

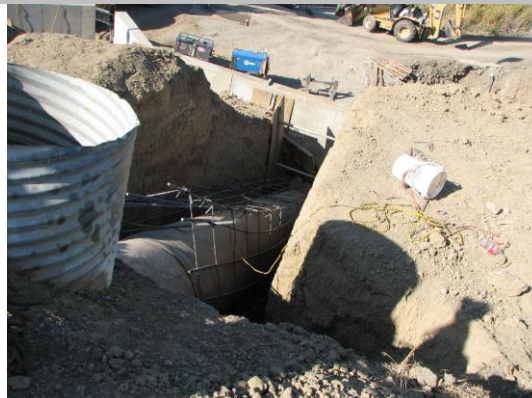
Photo 3 of 3 : UCIP\_FA\_2018\_37894\_68951.jpg

Comment Code						
Inspector Comment						
FS_ID:37894 DS_ID:17883 EP_NO: 18116 Repair Type: Non-Urgent Crossing Status: Found UCIP Comments: Under construction Oct-2009. Need updated photos of completed structure. FIELD_STRUCT_DESC: [West Sacramento Main Darin Pump Station] 4 of 4. 54-inch steel drainage pipe through the levee, 12.9 feet below the crown. Pump house is located on the landside (LS) and siphon breaker is located on the waterside (WS) slope. (four 54-inch pipes authorized under Permit No. 18116, 2007 - Reclamation District No. 900 [RD0900]; existing dual 48-inch pipes (60-inch pipes referenced in permit) removed; dual 48-inch pipes authorized under Permit No. 4257, 4257-A, 1963 - RD0900) [Additional Reference(s): DWR Levee Log, 2003] FS Date: 10/5/2009

Construction of structures in Oct-2009, photo 3 of 3.
